Manhole Inspection Summary

Manhole # S37U__004MH

Location Address: **132 E randall st**

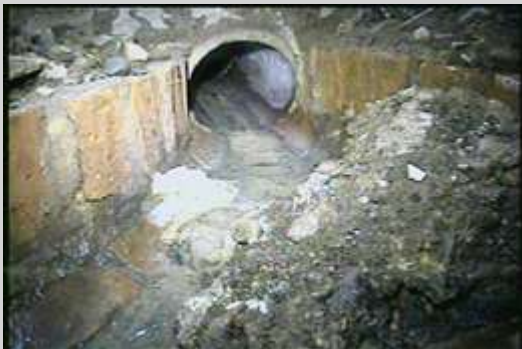
3 O'Clock Inflow

6 in. Circular Gravity Sewer
Pipe In @ 3 O'Clock

Pipe Material: **Clay** ☐ Pipe Lined

Invert Depth: 9.20 (ft.) Flow Characteristics: **Slow**

Deposits: ☒ **None** ☐ Mud ☐ Sludge ☐ Debris ☐ Grease

Silt Depth: 1 (in.) Deposits Extent: **Light**

Infiltration: **None** Pipe Seal Cond: **Unknown**

Connects To: **House connection / Service line**

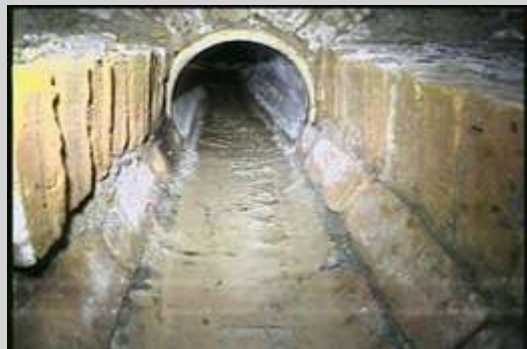
6 O'Clock Inflow

8 in. Circular Gravity Sewer
Pipe In @ 6 O'Clock

Pipe Material: **Clay** ☐ Pipe Lined

Infiltration: **None** Pipe Seal Cond: **Unknown**
